**Flood Control Project Maintenance
Levee Inspections**
LMA District Cover Sheet
Spring 2011 Levee Inspection Results

Reclamation District No. 2058 Pescadaro

Levee Inspection Report By Mile - Spring 2011

Waterway							Bank	Unit Miles	Inspection Start/End	Inspector
Unit No. 01 Paradise Cut							Left	6.71	03/23/2011 03/23/2011	Jim Eto
LMR No.	Levee Mile		Category	Item	Location	Rating	Action/Comment	GPS Latitude/Longitude		Issue No.
	Start	End						Start	End	Photo
1	0.00	0.10	Earthen Levee	Vegetation	CR	A	Control annual grass and weeds on the levee slopes and easements.	37.801564 ° -121.420767 °	37.802800 ° -121.419858 °	13 Y
2	0.00	0.10	Earthen Levee	Vegetation	CR	C	Remove the wild growth other than native grasses from the levee slopes. Inspector Comments: Thistle should be mowed or otherwise removed.	37.801564 ° -121.420767 °	37.802800 ° -121.419858 °	4
3	0.05	0.05	Earthen Levee	Encroachments	WS	C	Debris Inspector Comments: Rusted metal pipe and concrete is present within 20-ft of crown and should be removed.	37.802209 ° -121.420356 °	37.802209 ° -121.420356 °	946
4	0.14	0.14	Earthen Levee	Animal Control	LS	M	Exterminate rodents and backfill and compact or grout burrows.	37.803

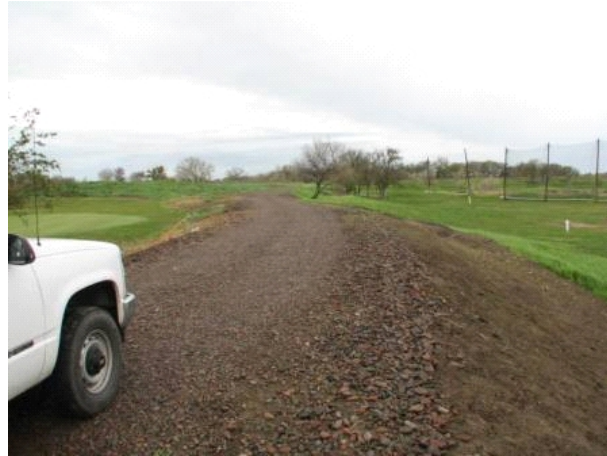
Levee Mile Report Line	1
Start Levee Mile	0.00
End Levee Mile	0.10
Location	Crown
Category	Earthen Levee
Item	Vegetation
Updated photo taken 03/23/2011 noting vegetation removal in response to comments 1 and 6 from Fall 2010 inspection.	
jeto_s_20110406_359.jpg

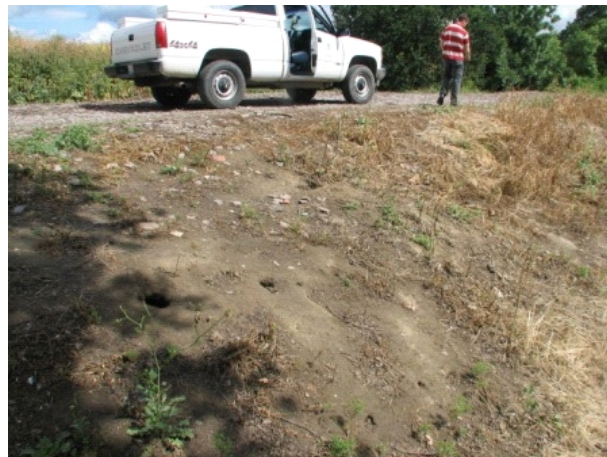
Levee Mile Report Line	4
Start Levee Mile	0.14
End Levee Mile	0.14
Location	Land Side
Category	Earthen Levee
Item	Animal Control
Active animal burrows on landside slope.	
jeto_s_20110301_121.jpg

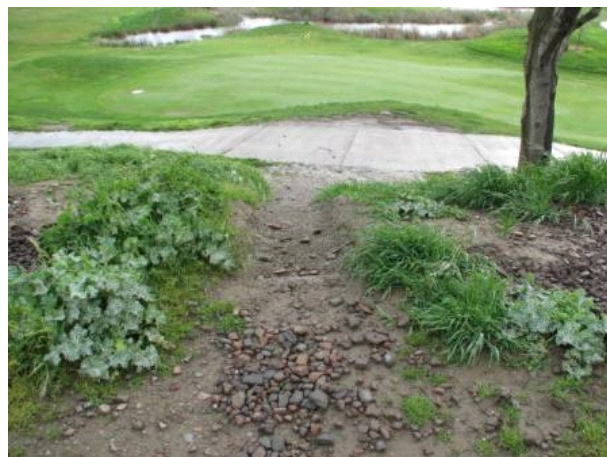
Levee Mile Report Line	7
Start Levee Mile	0.25
End Levee Mile	0.25
Location	Land Side
Category	Earthen Levee
Item	Encroachments
Photo taken 03/23/2011 stairs cut into landside of levee.	
jeto_s_20110329_350.jpg

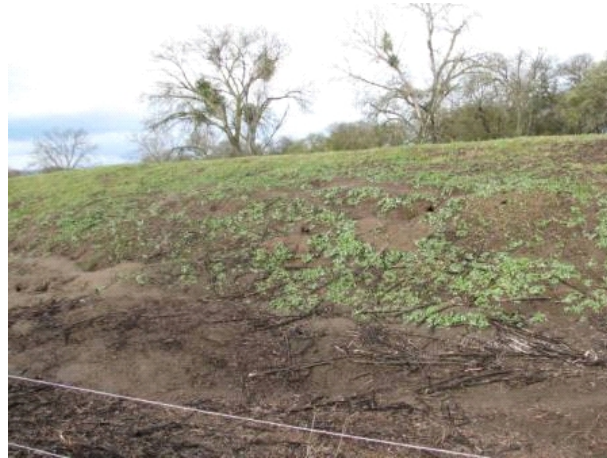
Levee Mile Report Line	8
Start Levee Mile	0.26
End Levee Mile	0.26
Location	Water Side
Category	Earthen Levee
Item	Animal Control
Burrows on water side of levee road, exposed after vegetation was removed. Vegetation was removed in response to comment #9 in fall 2010 inspection. Photo taken 03-23-2011	
jeto_s_20110325_342.jpg

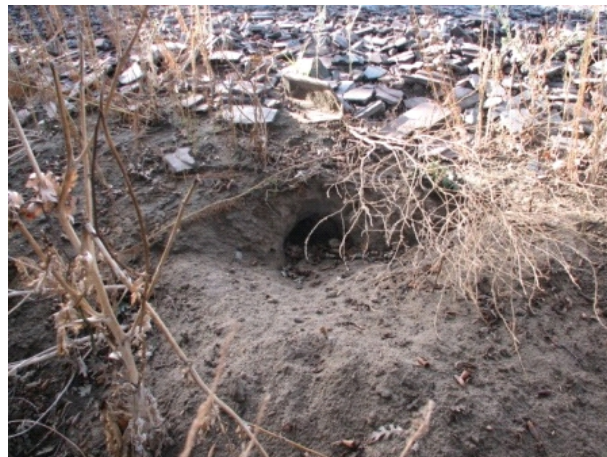
Levee Mile Report Line	9
Start Levee Mile	0.29
End Levee Mile	0.34
Location	Water Side
Category	Earthen Levee
Item	Animal Control
Rodent hole on levee slope near crown.	
jeto_s_20110301_137.jpg

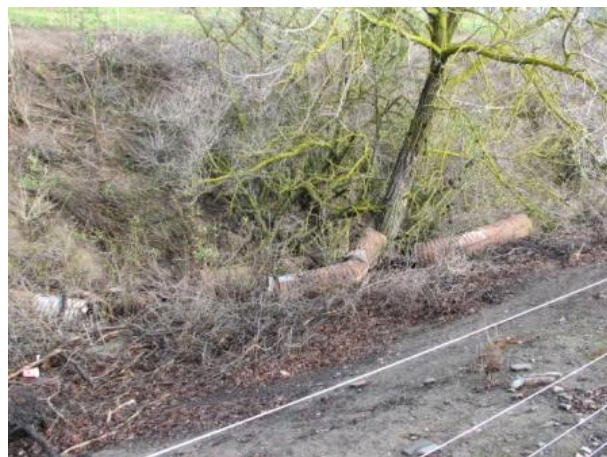
Levee Mile Report Line	10
Start Levee Mile	0.33
End Levee Mile	0.33
Location	Water Side
Category	Earthen Levee
Item	Encroachments
CMP on water side needs to be removed photo taken 03/25/2011	
jeto_s_20110325_341.jpg

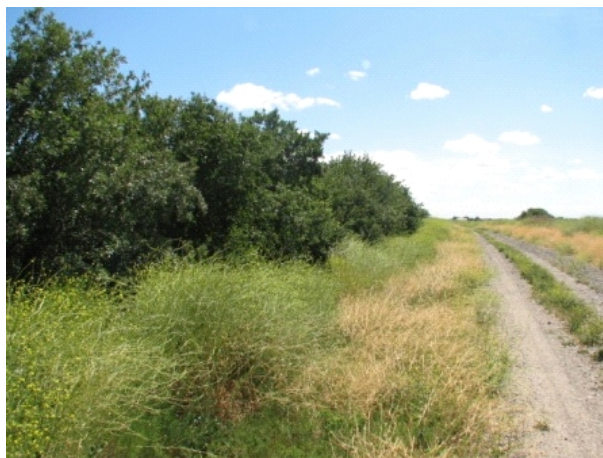
Levee Mile Report Line	14
Start Levee Mile	0.82
End Levee Mile	0.93
Location	Water Side
Category	Earthen Levee
Item	Trim / Thin Trees

Dense trees on waterside slope obstruct access and visibility.

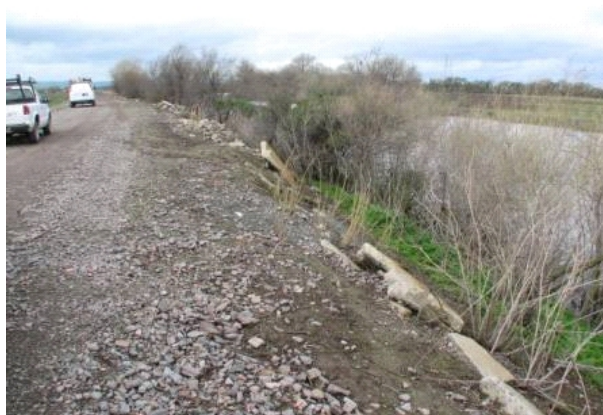
Levee Mile Report Line	14
Start Levee Mile	0.82
End Levee Mile	0.93
Location	Water Side
Category	Earthen Levee
Item	Trim / Thin Trees

Vegetation removal has improved visibility, however, minimal tree pruning and no removal allowed by FWS because of RBR habitat.

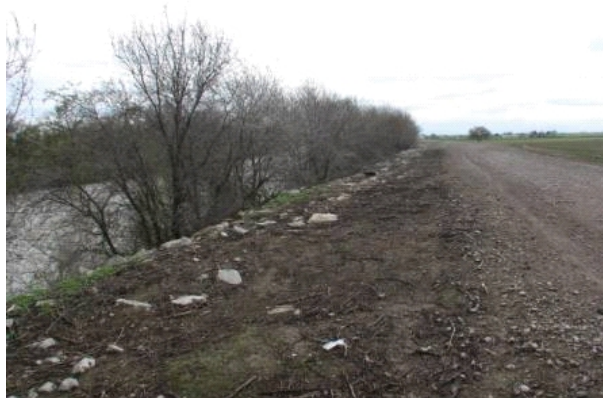
Levee Mile Report Line	14
Start Levee Mile	0.82
End Levee Mile	0.93
Location	Water Side
Category	Earthen Levee
Item	Trim / Thin Trees

Vegetation removal has improved visibility, however, minimal tree pruning and no removal allowed by FWS because of RBR habitat.

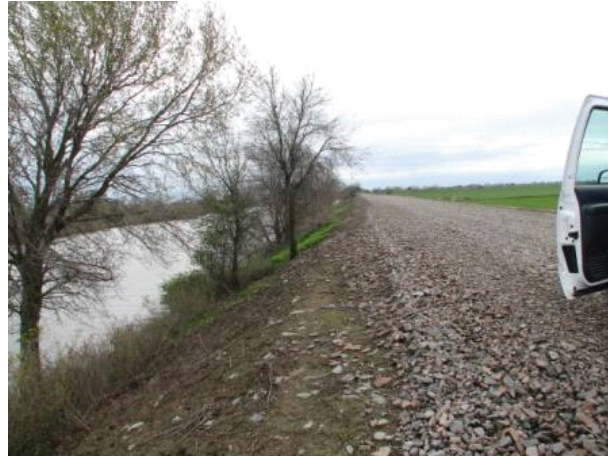
Levee Mile Report Line	17
Start Levee Mile	1.22
End Levee Mile	1.22
Location	Water Side
Category	Earthen Levee
Item	Vegetation

03/23/11 the issue has been corrected by the enactment of a goat grazing program, coord. w/ FWS.

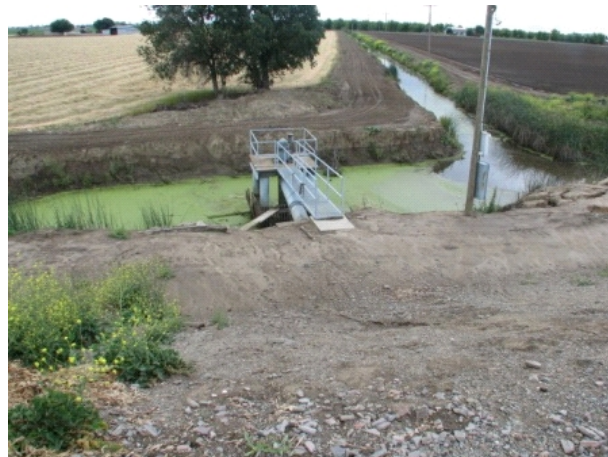
Levee Mile Report Line	19
Start Levee Mile	1.24
End Levee Mile	1.24
Location	Crown
Category	Earthen Levee
Item	Encroachments

Drainage discharge to Paradise Cut.

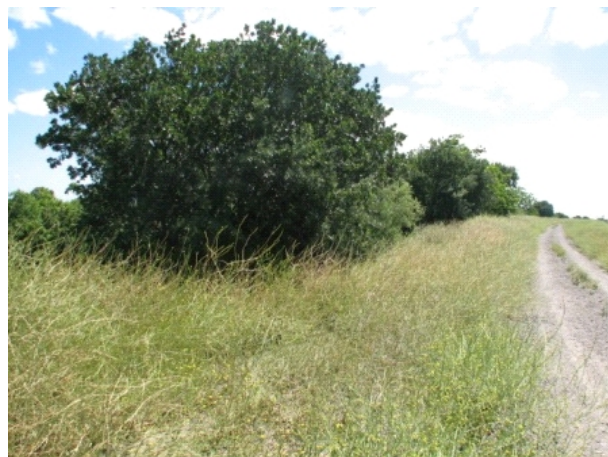
Levee Mile Report Line	28
Start Levee Mile	1.89
End Levee Mile	1.92
Location	Water Side
Category	Earthen Levee
Item	Trim / Thin Trees

Dense trees on top 20' of waterside slope obstructs access and visibility.

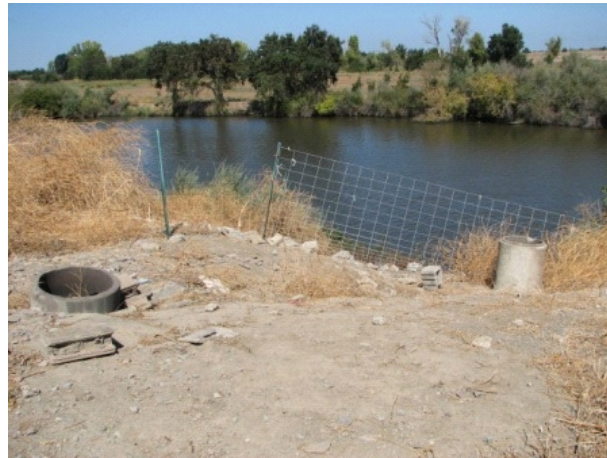
Levee Mile Report Line	30
Start Levee Mile	2.15
End Levee Mile	2.15
Location	Water Side
Category	Supplemental
Item	DWR Erosion Survey
Downstream view of site. Note the fenced area	
jeto_s_20110301_116.jpg

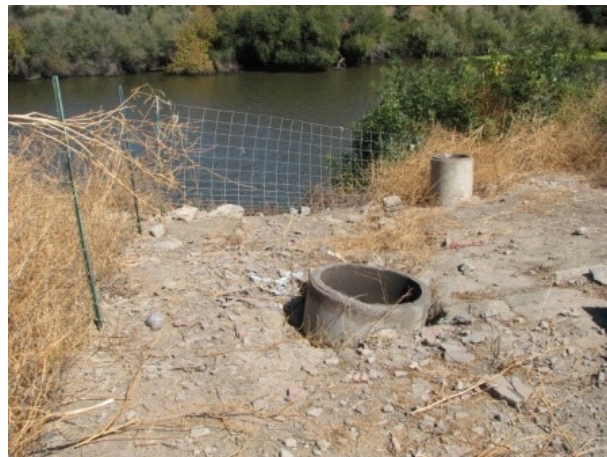
Levee Mile Report Line	30
Start Levee Mile	2.15
End Levee Mile	2.15
Location	Water Side
Category	Supplemental
Item	DWR Erosion Survey
Direct view of siphon breaker.	
jeto_s_20110301_117.jpg

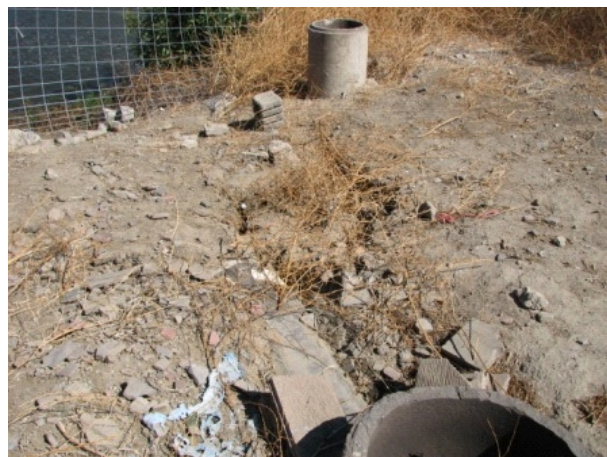
Levee Mile Report Line	30
Start Levee Mile	2.15
End Levee Mile	2.15
Location	Water Side
Category	Supplemental
Item	DWR Erosion Survey
Direct view of siphon breaker.	
jeto_s_20110301_118.jpg

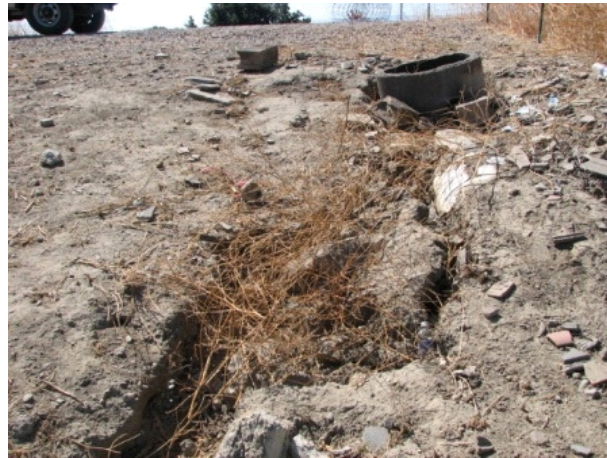
Levee Mile Report Line	30
Start Levee Mile	2.15
End Levee Mile	2.15
Location	Water Side
Category	Supplemental
Item	DWR Erosion Survey

Notches created by water leaking/overflowing from the siphon breaker.

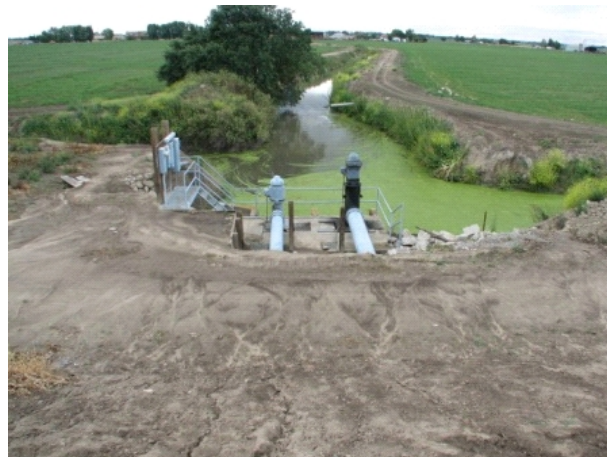
Levee Mile Report Line	31
Start Levee Mile	2.15
End Levee Mile	2.15
Location	Crown
Category	Earthen Levee
Item	Encroachments

Drainage discharge to Paradise Cut.

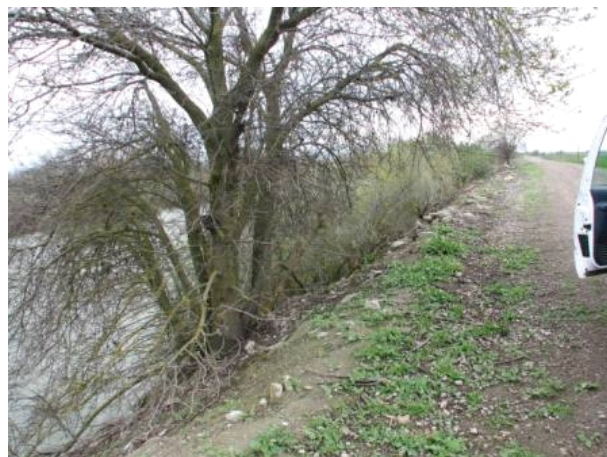
Levee Mile Report Line	34
Start Levee Mile	2.42
End Levee Mile	2.42
Location	Water Side
Category	Earthen Levee
Item	Trim / Thin Trees

Photo taken 03/23/2011 LM 2.42 Tree needs to be trimmed. Currently, only minimal pruning is allowed by FWS because of RBR habitat concerns.

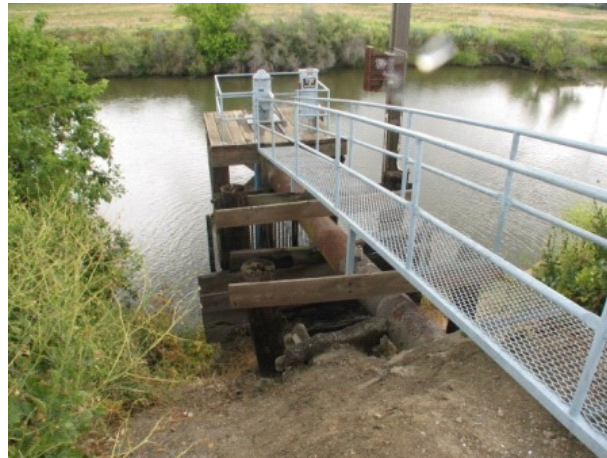
Levee Mile Report Line	35
Start Levee Mile	2.89
End Levee Mile	2.89
Location	Water Side
Category	Earthen Levee
Item	Encroachments

Irrigation intake from Paradise Cut.

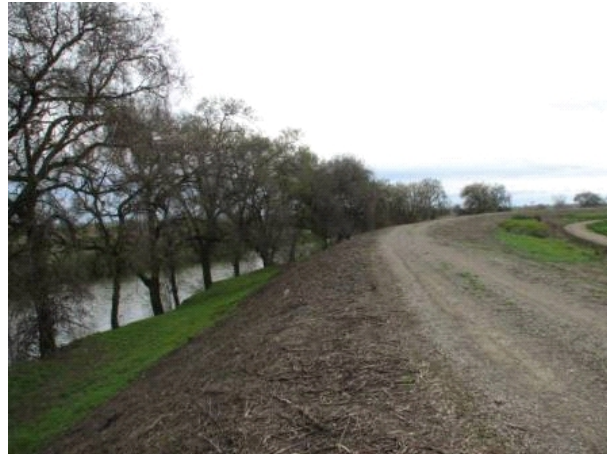
Levee Mile Report Line	36
Start Levee Mile	3.13
End Levee Mile	5.98
Location	Water Side
Category	Earthen Levee
Item	Vegetation

Photo taken 03/23/2011 shows vast improvement regarding vegetation issue on water side of levee.

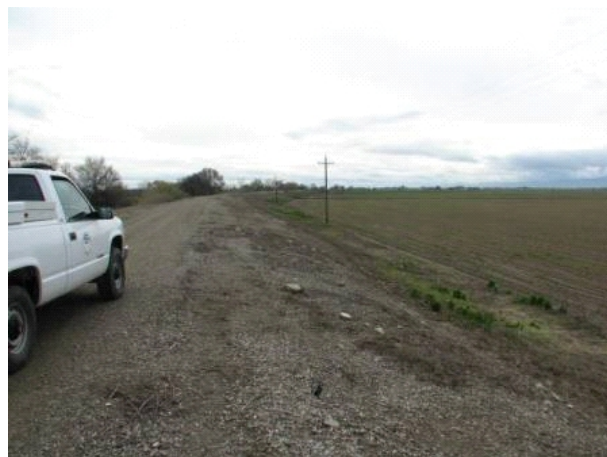
Levee Mile Report Line	37
Start Levee Mile	3.13
End Levee Mile	5.98
Location	Land Side
Category	Earthen Levee
Item	Vegetation

Photo taken 03/23/2011 showing vegetation removal on land side of levee.

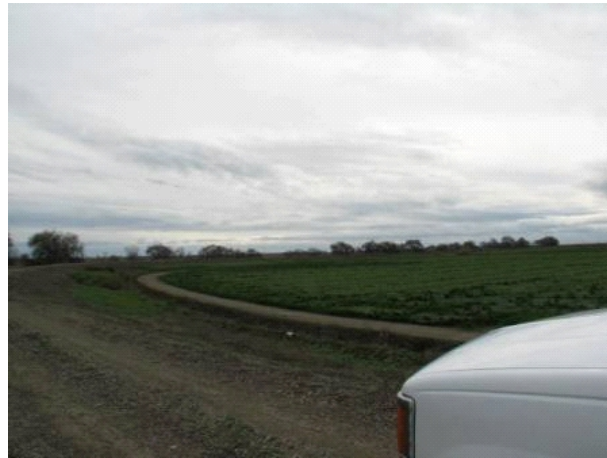
Levee Mile Report Line	37
Start Levee Mile	3.13
End Levee Mile	5.98
Location	Land Side
Category	Earthen Levee
Item	Vegetation

Photo taken 03/23/2011 showing vegetation removal on land side.

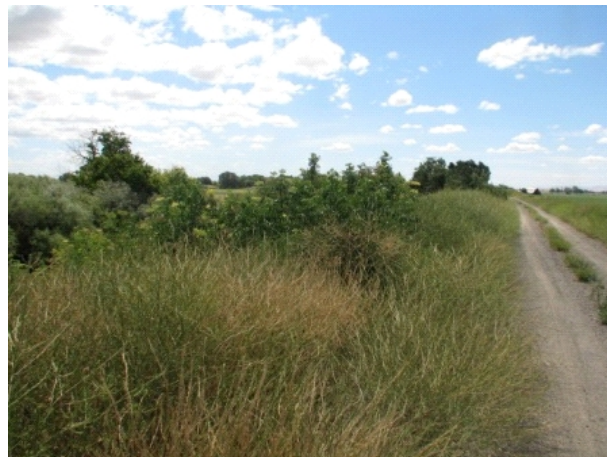
Levee Mile Report Line	43
Start Levee Mile	3.77
End Levee Mile	3.77
Location	Water Side
Category	Earthen Levee
Item	Vegetation

Tall brush on top 20' of waterside slope obstructs access and visibility.

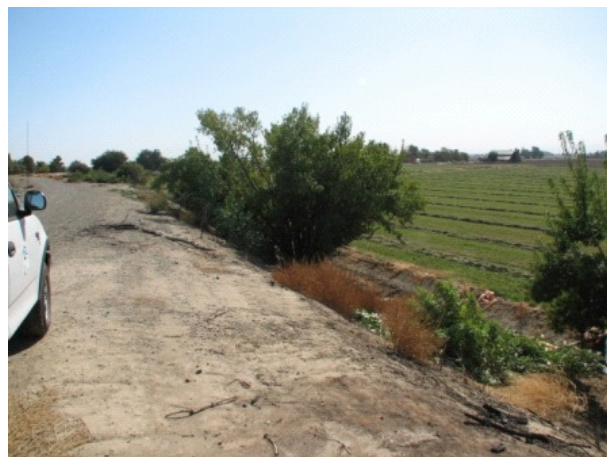
Levee Mile Report Line	44
Start Levee Mile	3.96
End Levee Mile	3.96
Location	Land Side
Category	Earthen Levee
Item	Trim / Thin Trees

Fall 2009 photo of trees needing trimming to allow access and visibility.

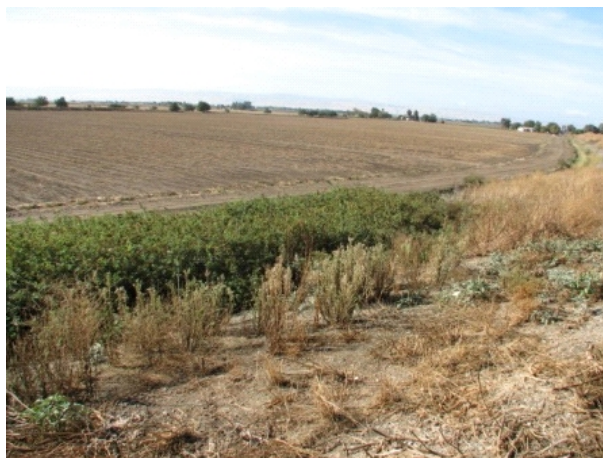
Levee Mile Report Line	49
Start Levee Mile	4.46
End Levee Mile	4.46
Location	Land Side
Category	Earthen Levee
Item	Vegetation

Wild rose on levee toe and slope obstructs access and visibility.

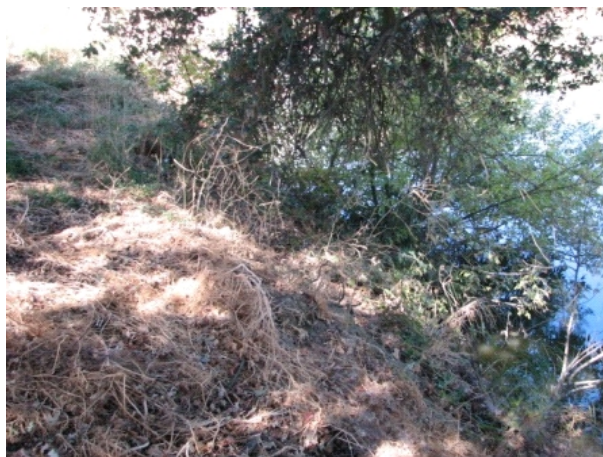
Levee Mile Report Line	50
Start Levee Mile	4.49
End Levee Mile	4.53
Location	Water Side
Category	Supplemental
Item	DWR Erosion Survey

Downstream view. Seasonal vegetation covering one of several pocket erosions lined along the bank.

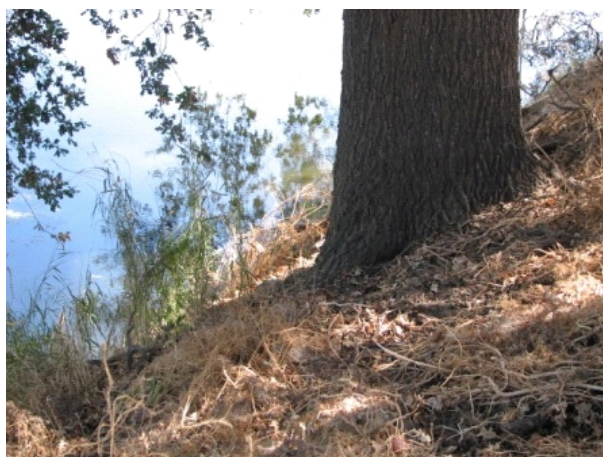
Levee Mile Report Line	50
Start Levee Mile	4.49
End Levee Mile	4.53
Location	Water Side
Category	Supplemental
Item	DWR Erosion Survey

Upstream view of the base of 1 of 2 large Oake trees on site. No signs of scouring on the base.

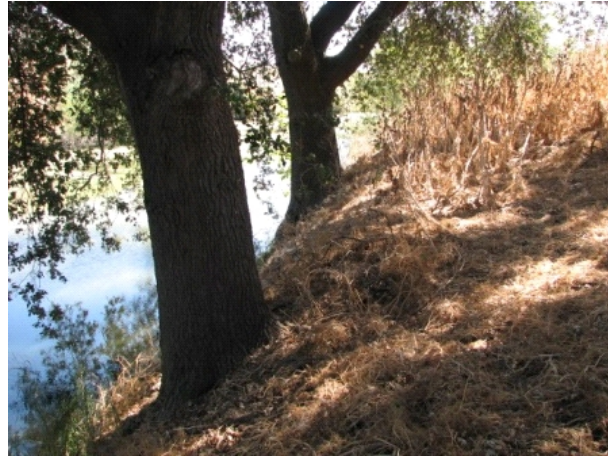
Levee Mile Report Line	50
Start Levee Mile	4.49
End Levee Mile	4.53
Location	Water Side
Category	Supplemental
Item	DWR Erosion Survey

Upstream view of both Oak trees located on the bench.

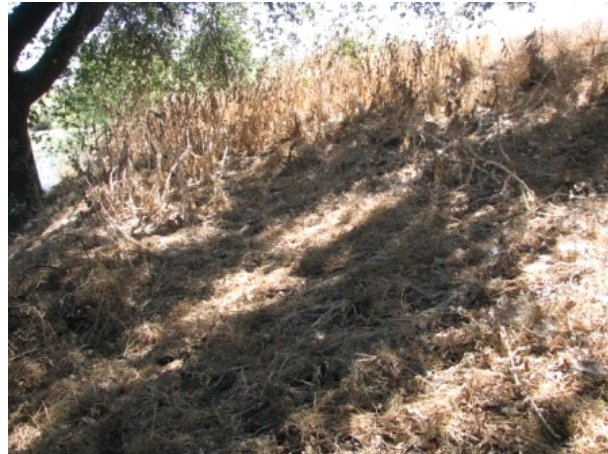
Levee Mile Report Line	50
Start Levee Mile	4.49
End Levee Mile	4.53
Location	Water Side
Category	Supplemental
Item	DWR Erosion Survey

Upstream view of the waterside slope. Vegetation on the slope was recently sprayed.
